Pavement Management (PM) Update

Pavement Management Inventory and Ranking

November 12, 2019

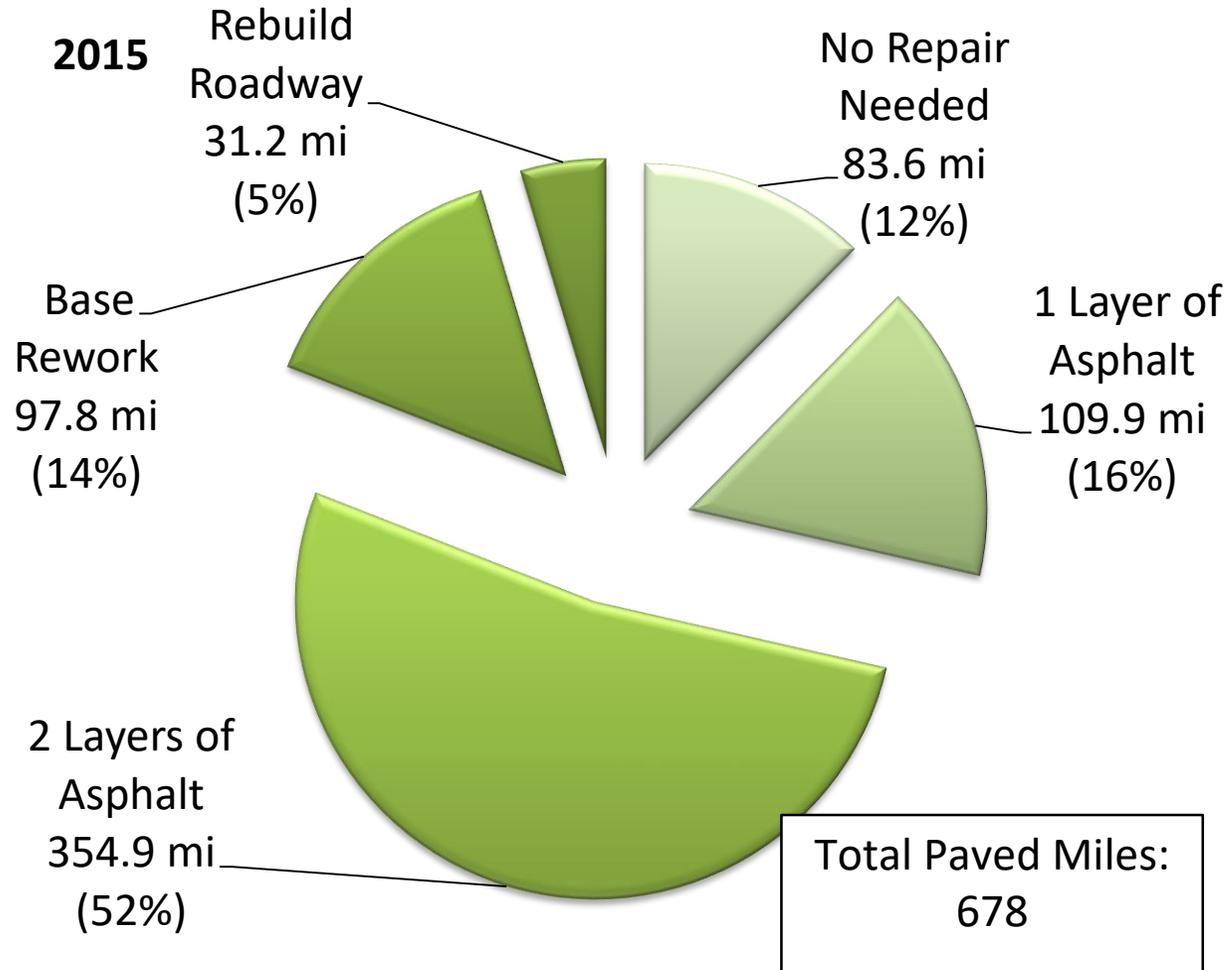
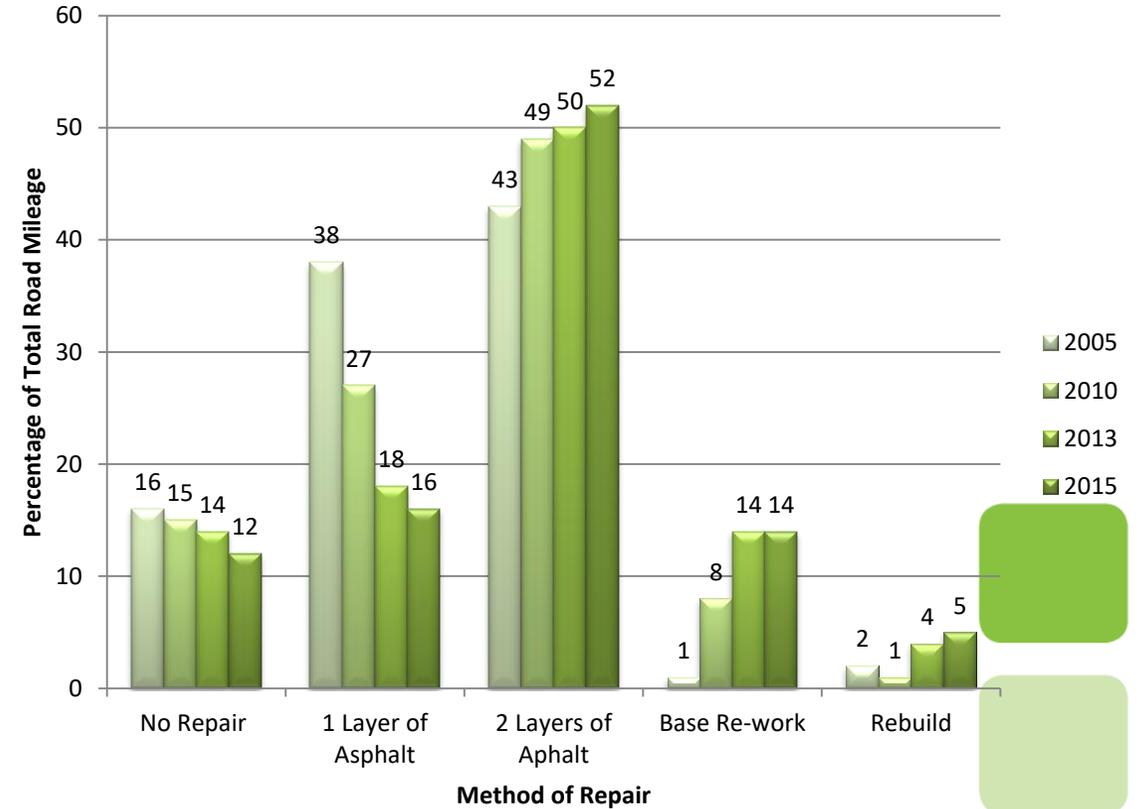
Pavement Condition Inventory vs. Time

**Inventory Condition
Backlog Continues to Grow**

**Inventory Condition Backlog
Continues to Grow
Update scheduled for 2020**

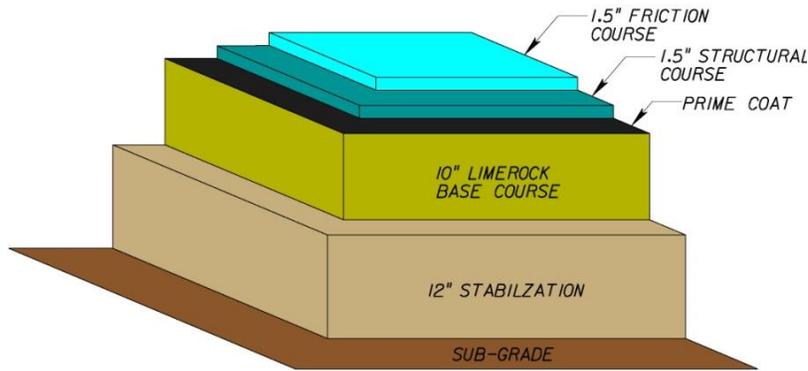
Pavement Structure

- **Goal**
 - **Sound foundation to support roadway loading & to keep water for infiltrating from the top to the bottom**

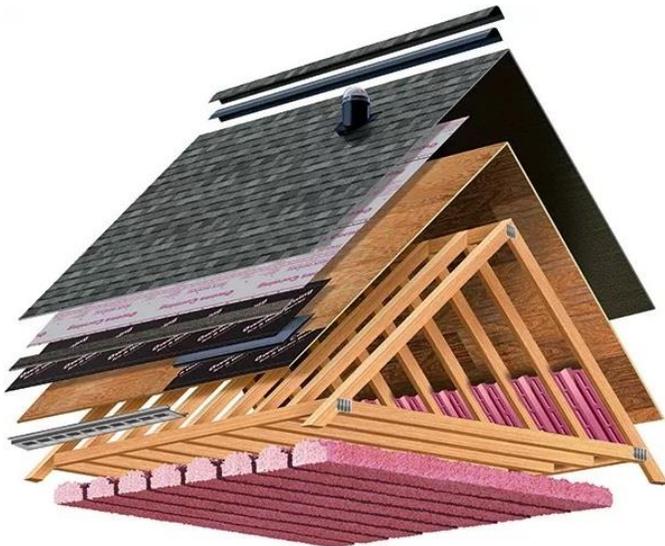
Pavement Structure Failures vs. Repair Types

- Friction course – Shingles
 - **Excellent** – 83 miles
- Structure course – Felt/moister barrier
 - **Good** – 110 miles
- Base course – Decking
 - **Fair** – 355 miles
- Stabilization – Trusses
 - **Poor** – 98 miles
- Sub-grade – Building Interior
 - **Very Poor** – 31 miles

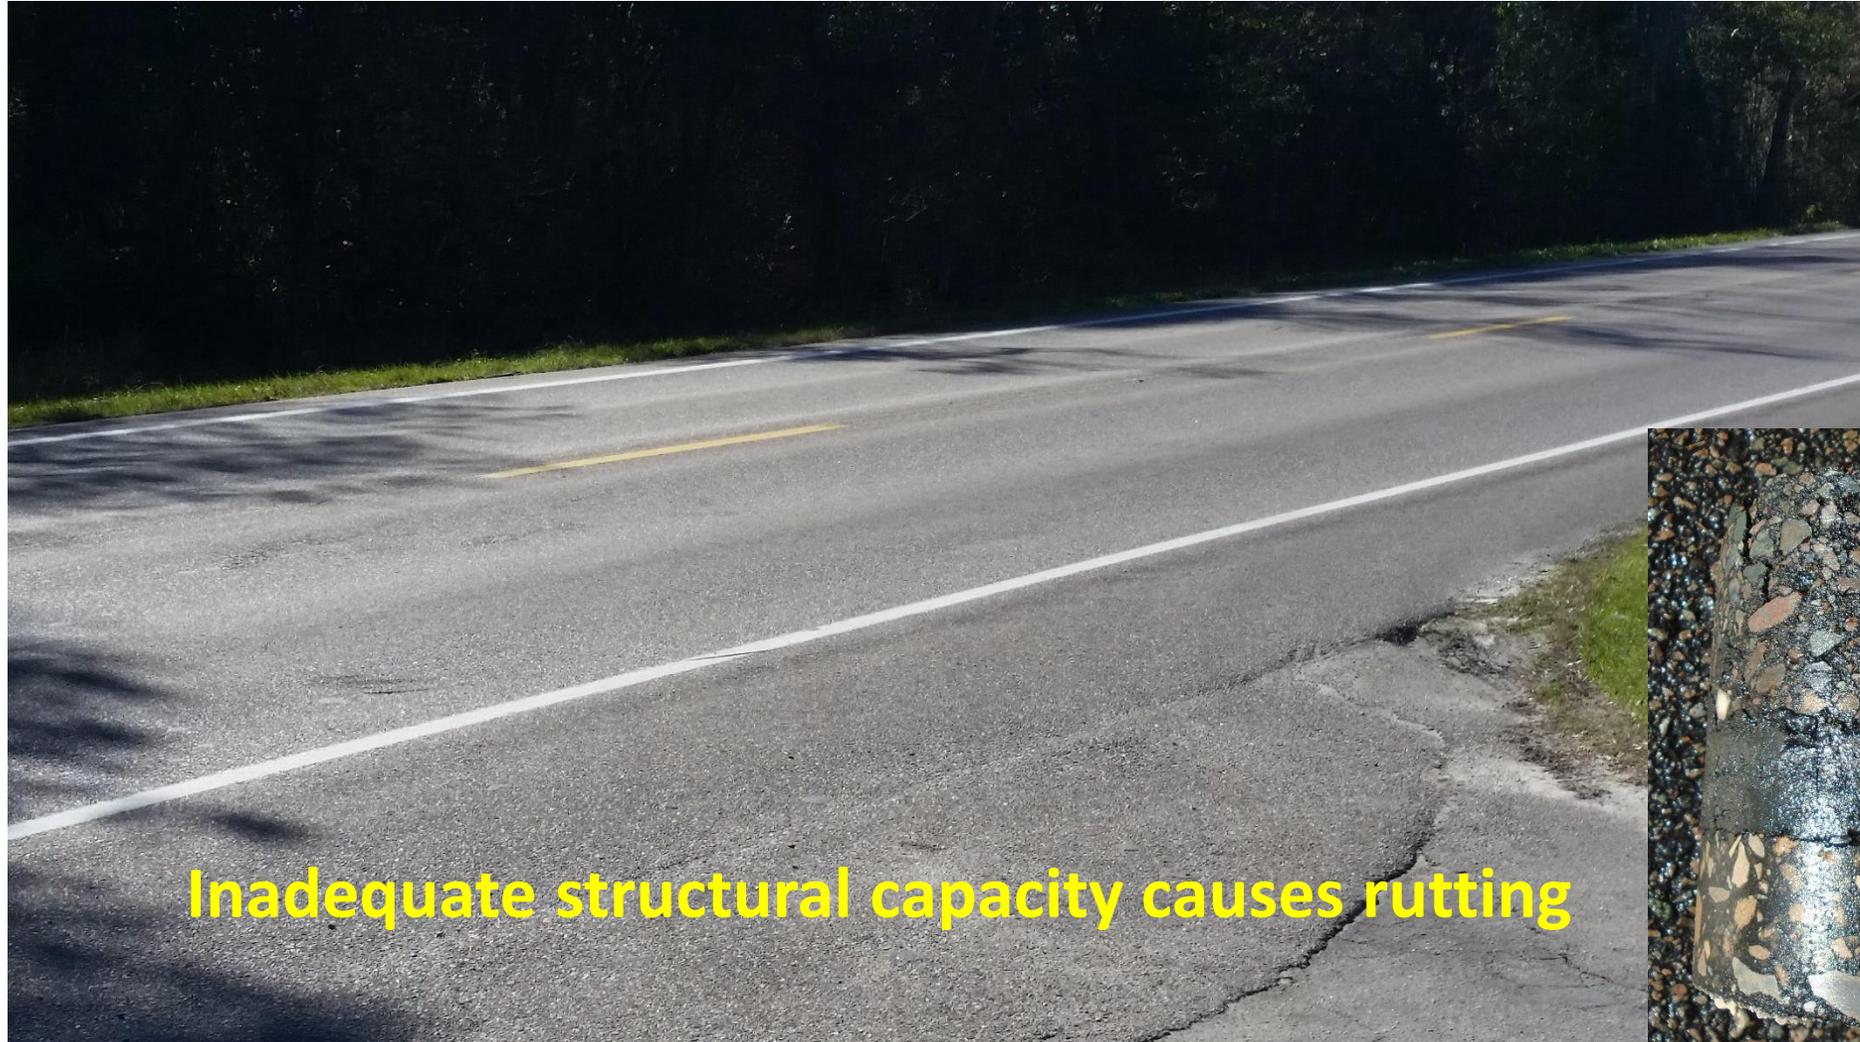
Pavement Failures

Inadequate structural capacity causes rutting

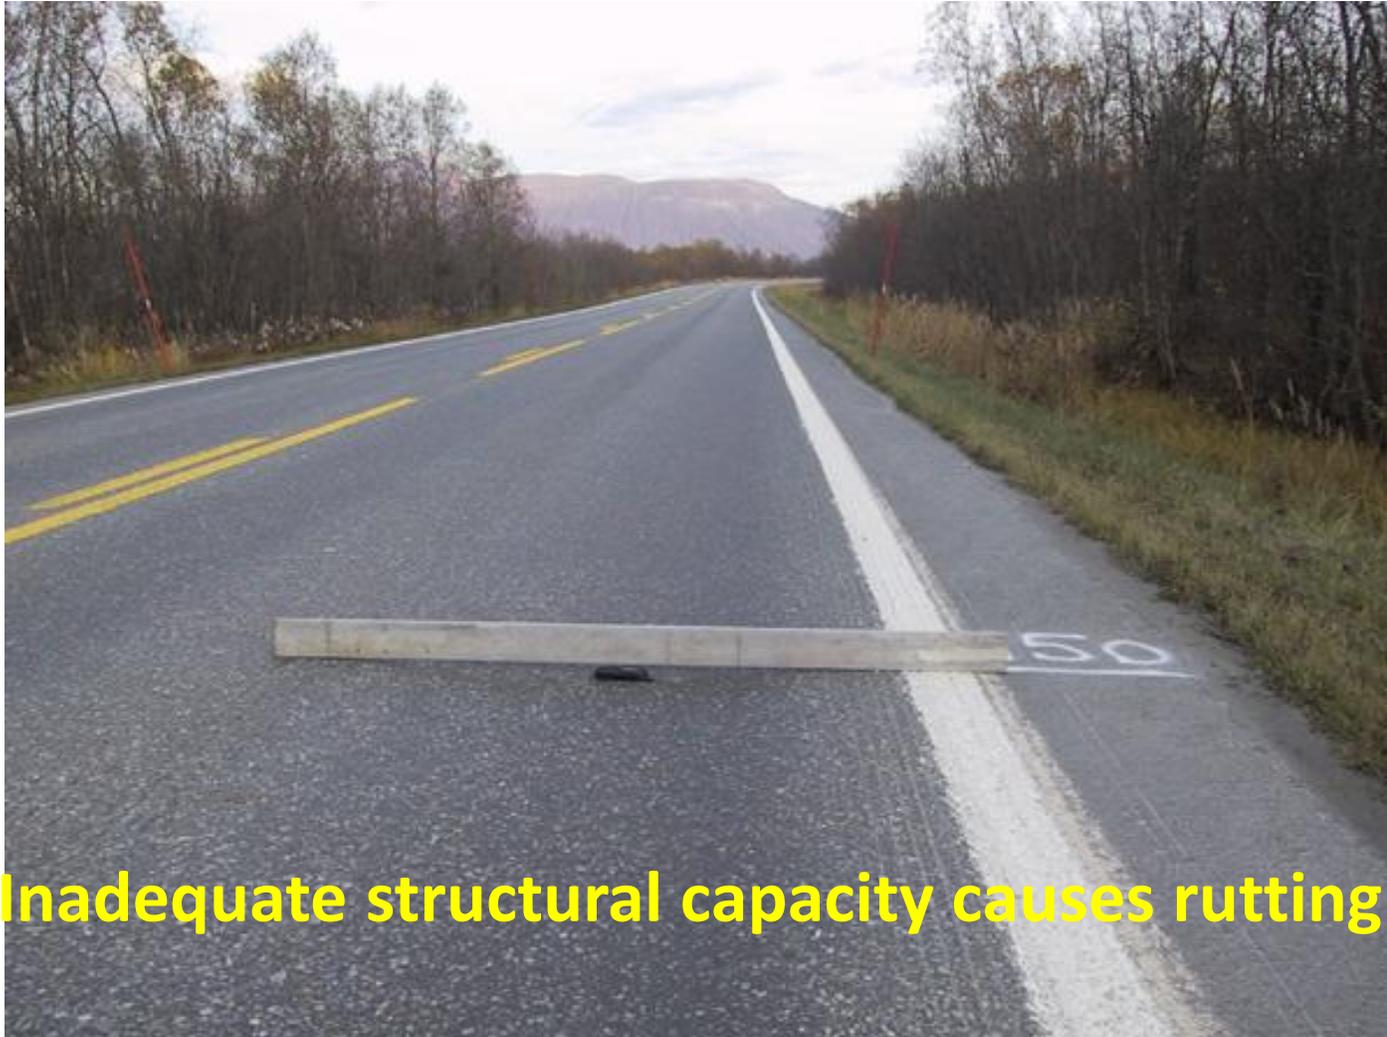
Pavement Failures

Inadequate structural capacity causes rutting

Caused by traffic loading

Pavement is not strong enough to support traffic loads

Preserving pavement is not possible

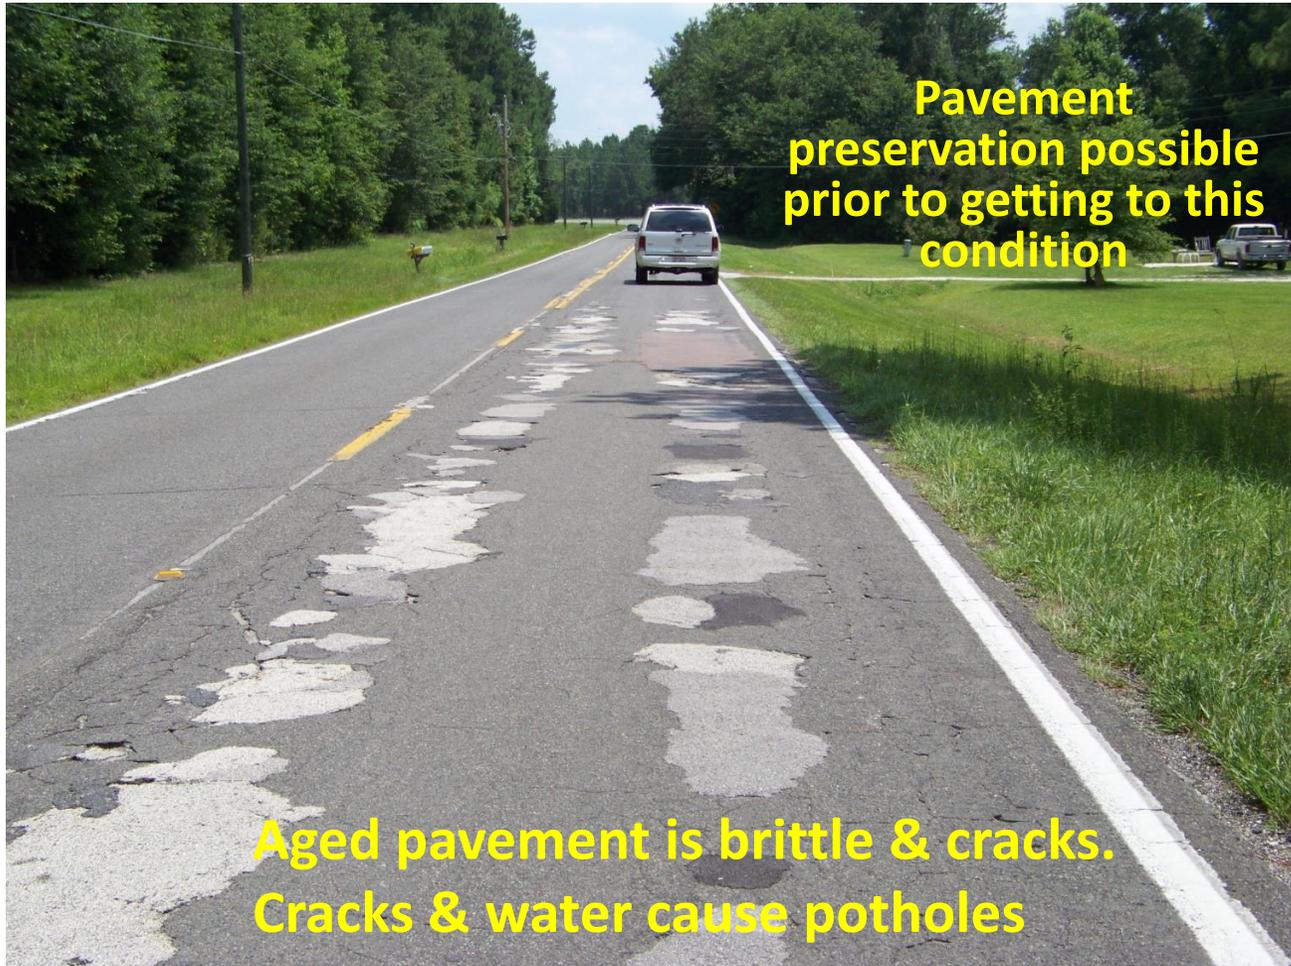
Pavement Failures

Pavement oxidizes and loses flexibility

Pavement cracks

Water intrusion & potholes

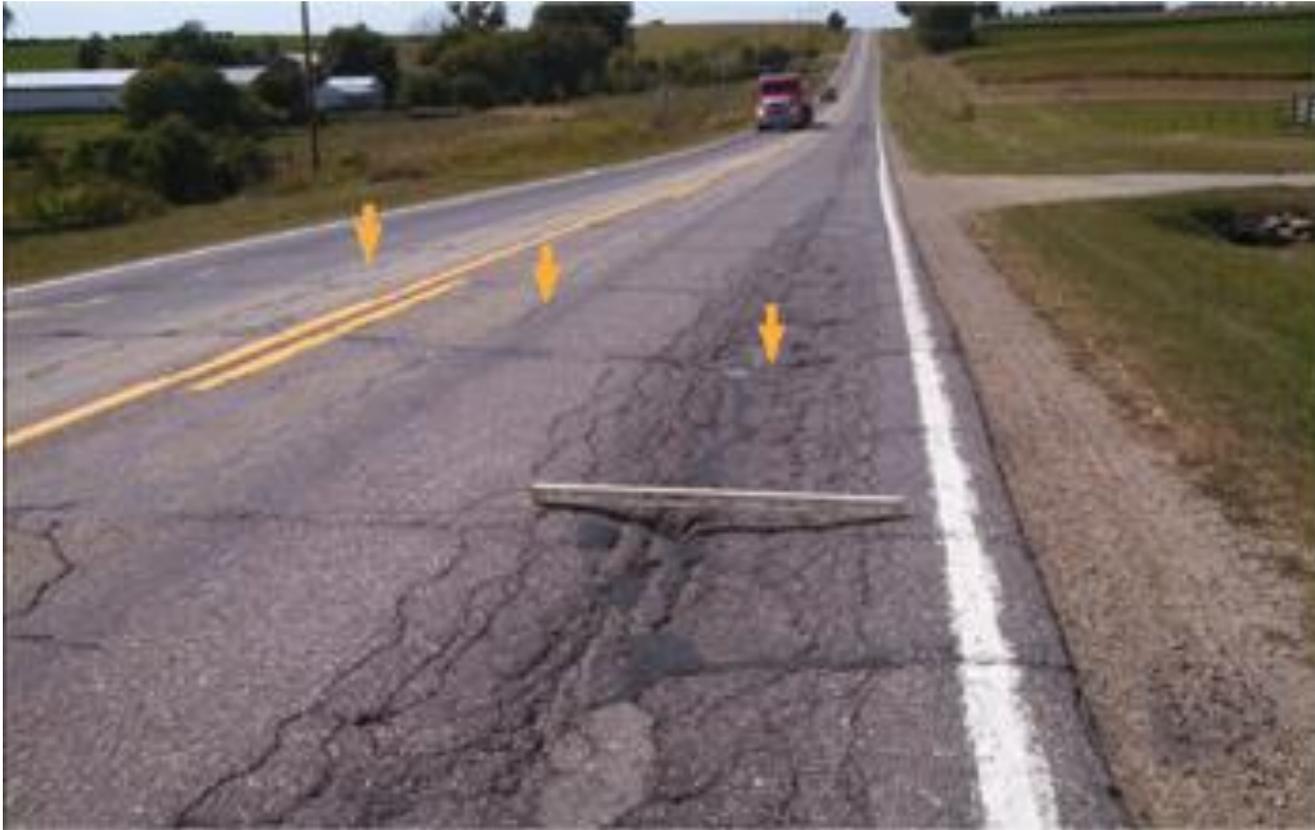
Pavement Failures

**Combination of aged
pavement and inadequate
structural capacity**

**Pavement preservation
not possible**

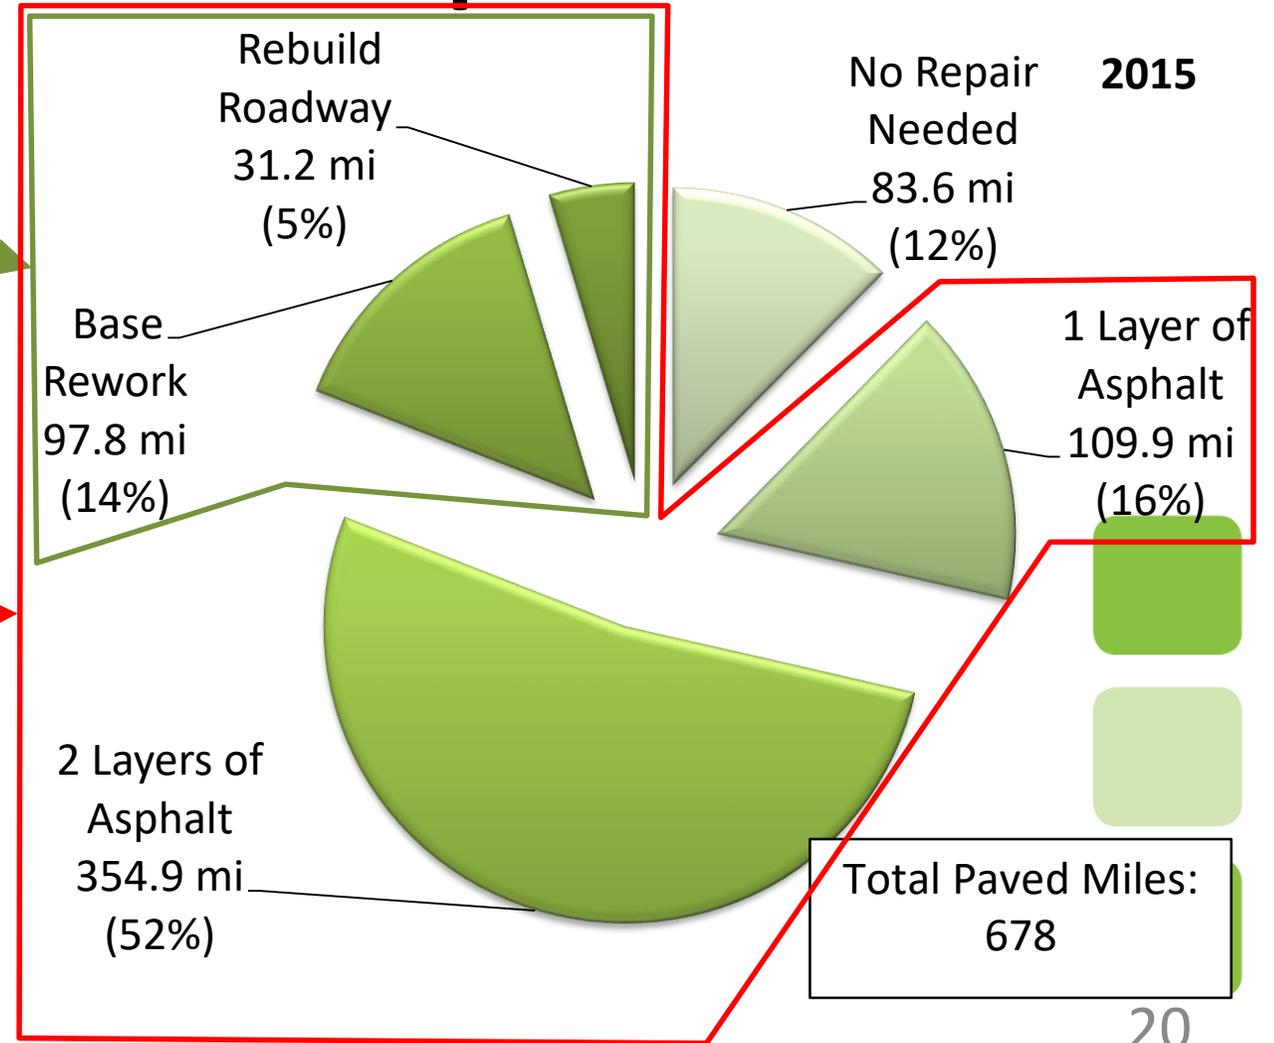
Pavement Management Techniques

Worst-First Approach
All funding goes to bottom end of inventory

Optimization Approach
Funding is spread throughout inventory to minimize backlog

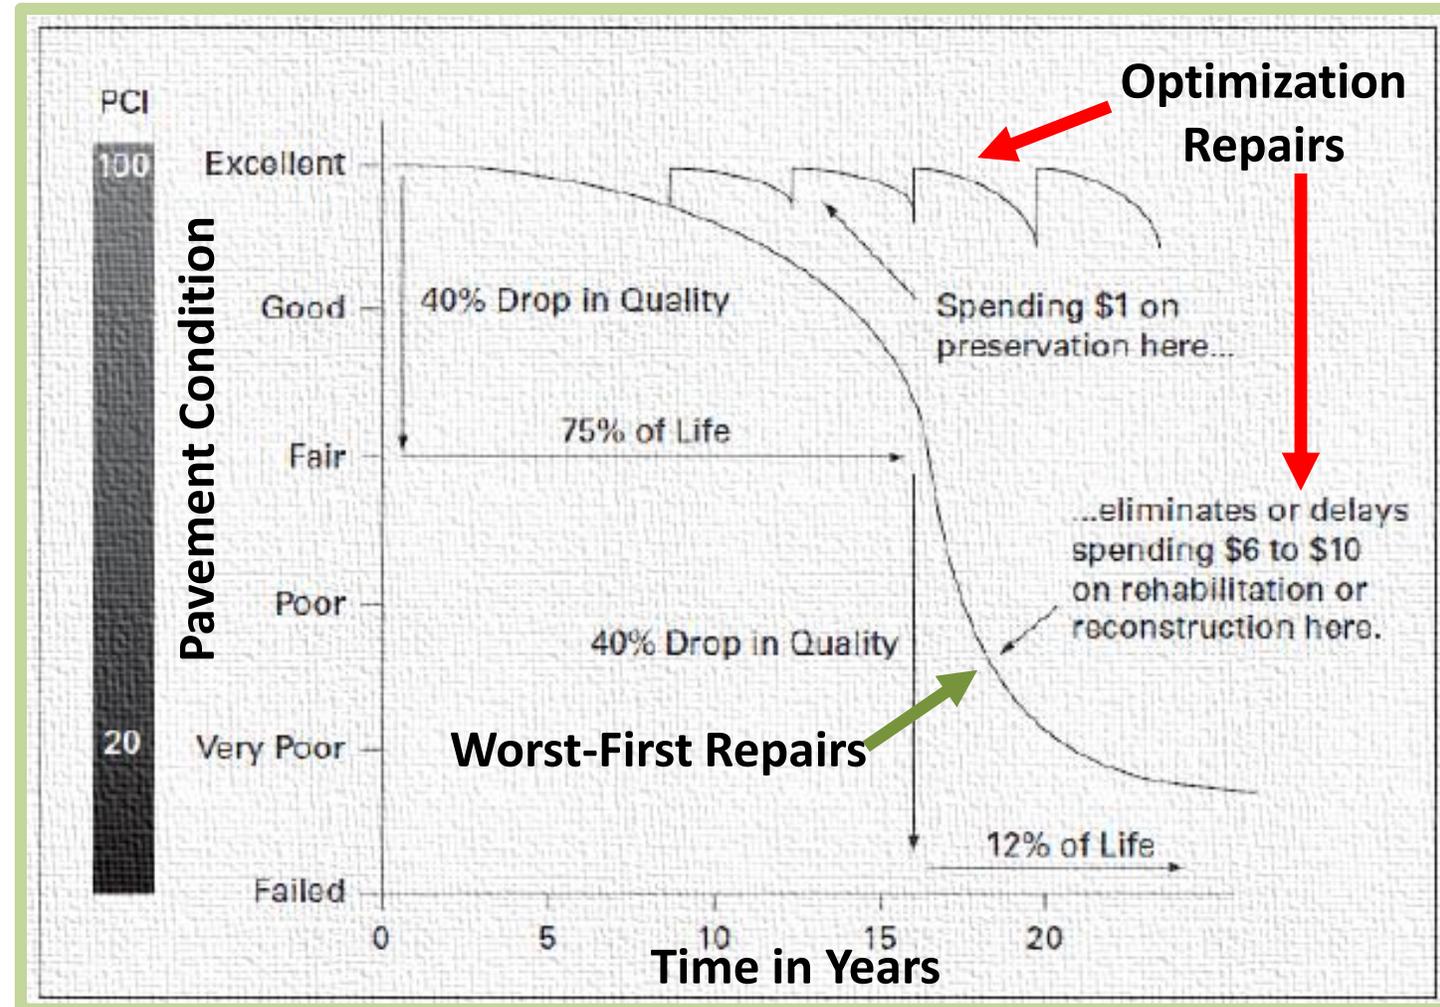
Pavement Management Techniques

- Pavements can be preserved at a frequent cycle at fraction of the costs without having to replace asphalt
- Alternatively pavements can be replaced at the end of the life at a higher cost
- Optimization utilizes both repair techniques, splitting the budget between the types of repairs in order to minimize the backlog

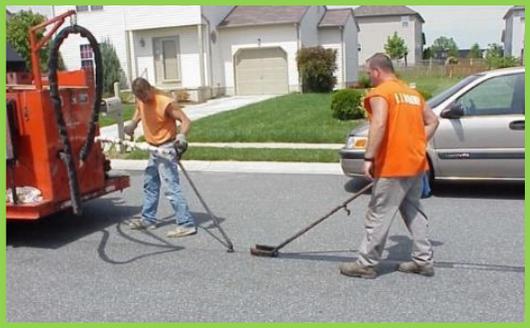
Crack Sealing

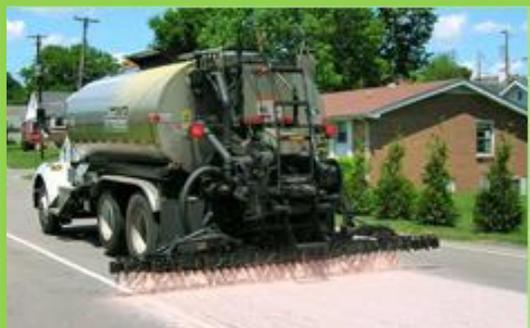
Rejuvenation

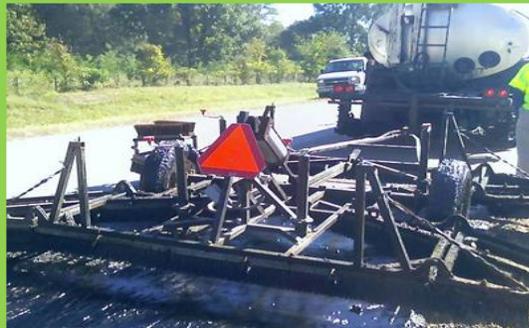
Sealing

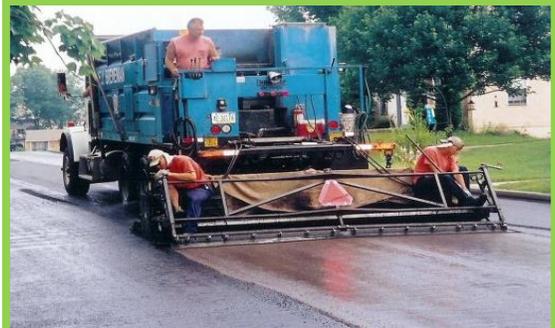
Microsurfacing

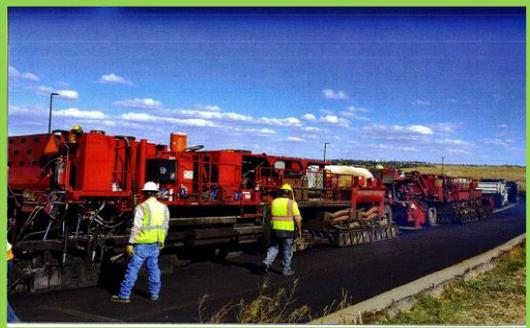
**Hot In-Place
Recycle**

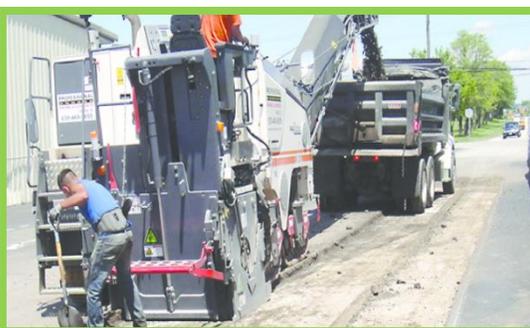
Mill & Resurface

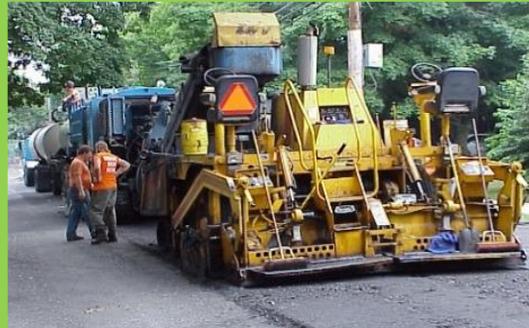
**Cold In-Place
Recycle**

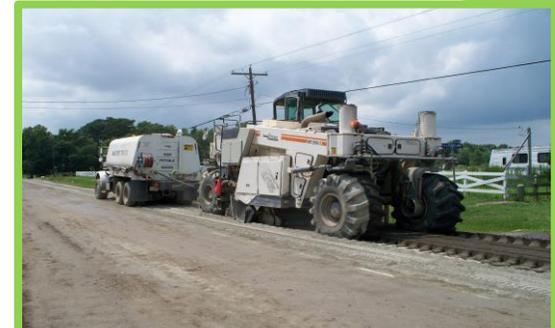
**Full Depth
Reclamation /
Reconstruction**

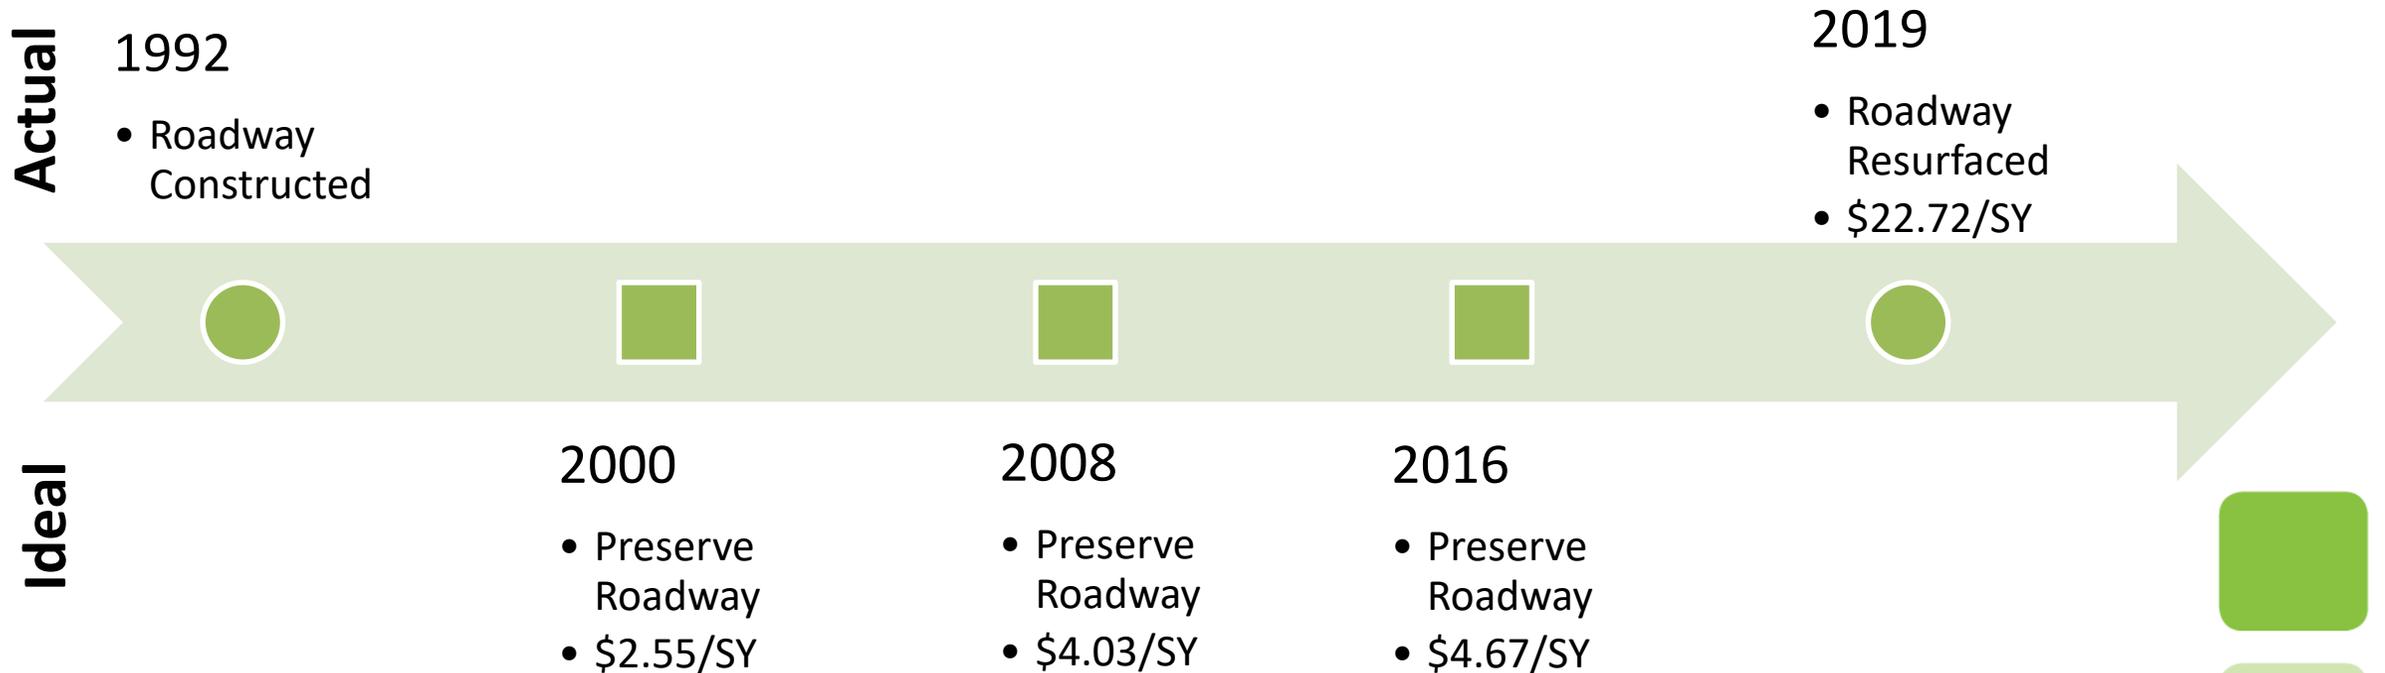
Roadway Example – NW 43rd Street

- **Pavement Preservation - \$11.25/SY or \$2.34 M**
- **Delayed (Actual) Resurfacing - \$22.72/SY or \$4.72 M**
- **Estimated sunk cost - \$2.38 M**

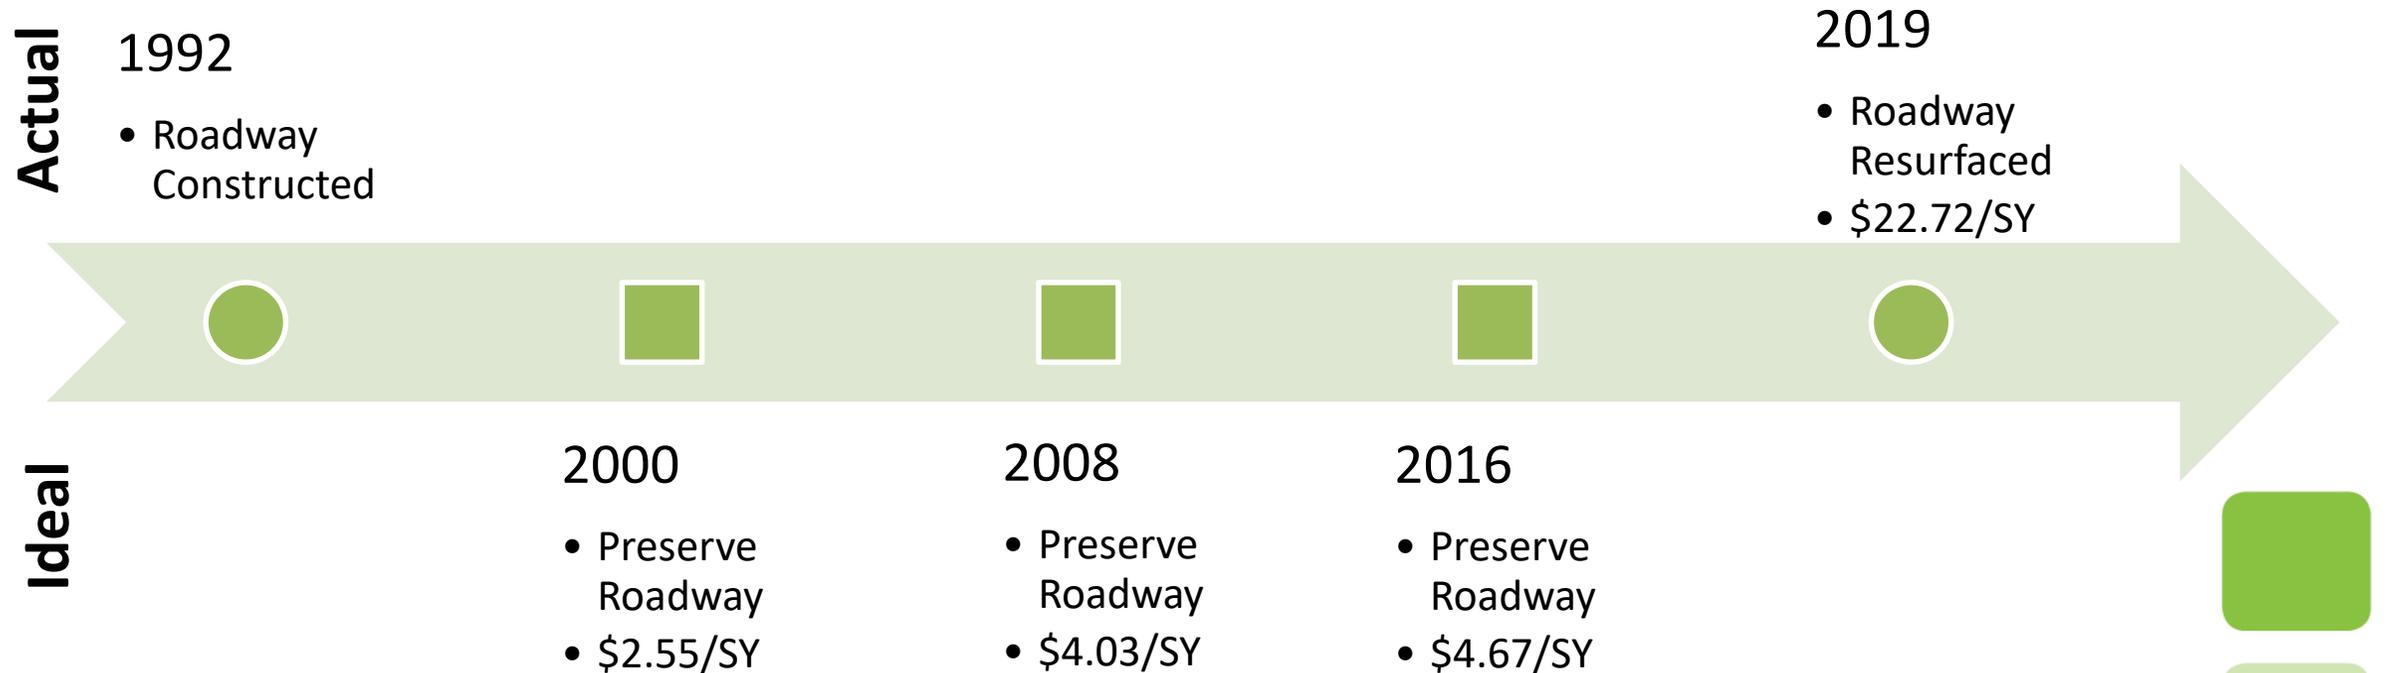
Roadway Example – NW 43rd Street

- **Ideal Resurfacing (2008) - \$9.99/SY or \$2.08 M**
- **Pavement Preservation (2 cycles) - \$6.58/SY or \$1.37 M**
- **Cost difference - \$0.71 M**

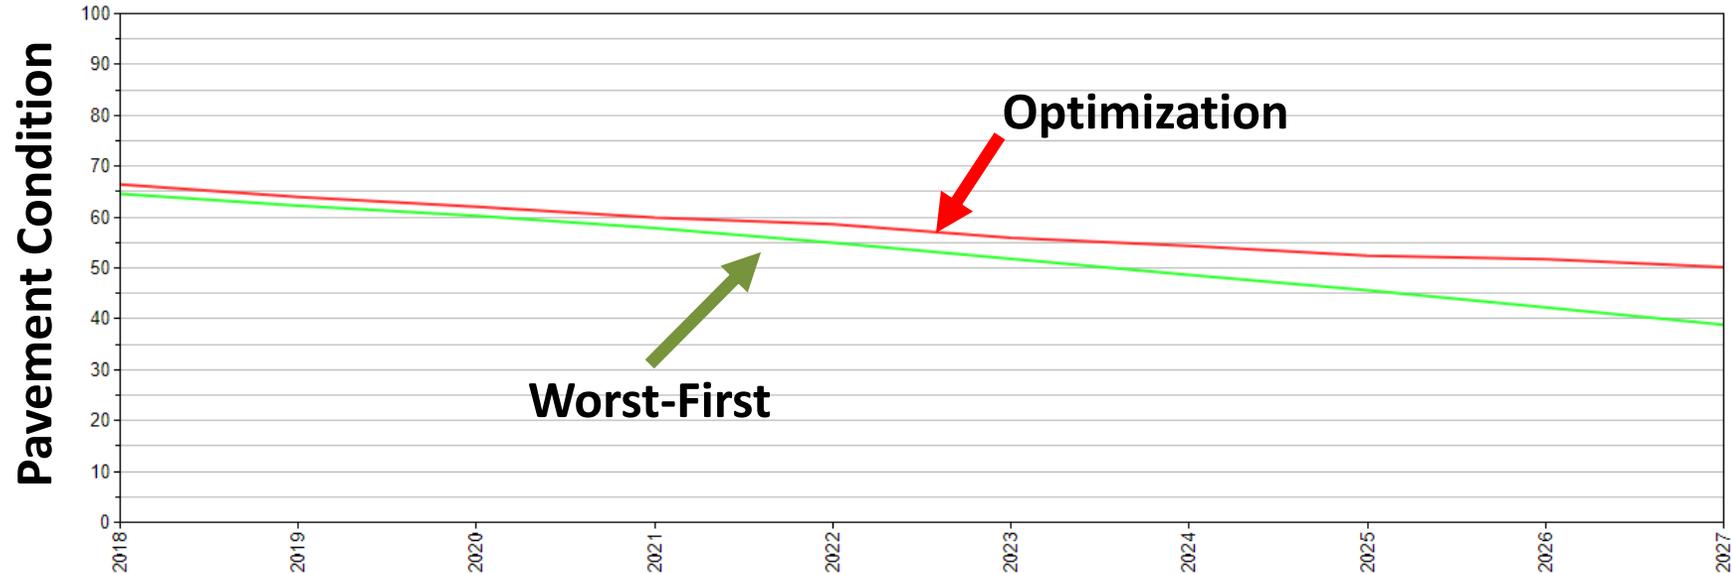
**Network
condition
vs.
Time**

Average PCI in 2027

Optimized PCI: 50

Worst-First PCI: 38

**Network Condition
Improvement:
12 PCI Points**

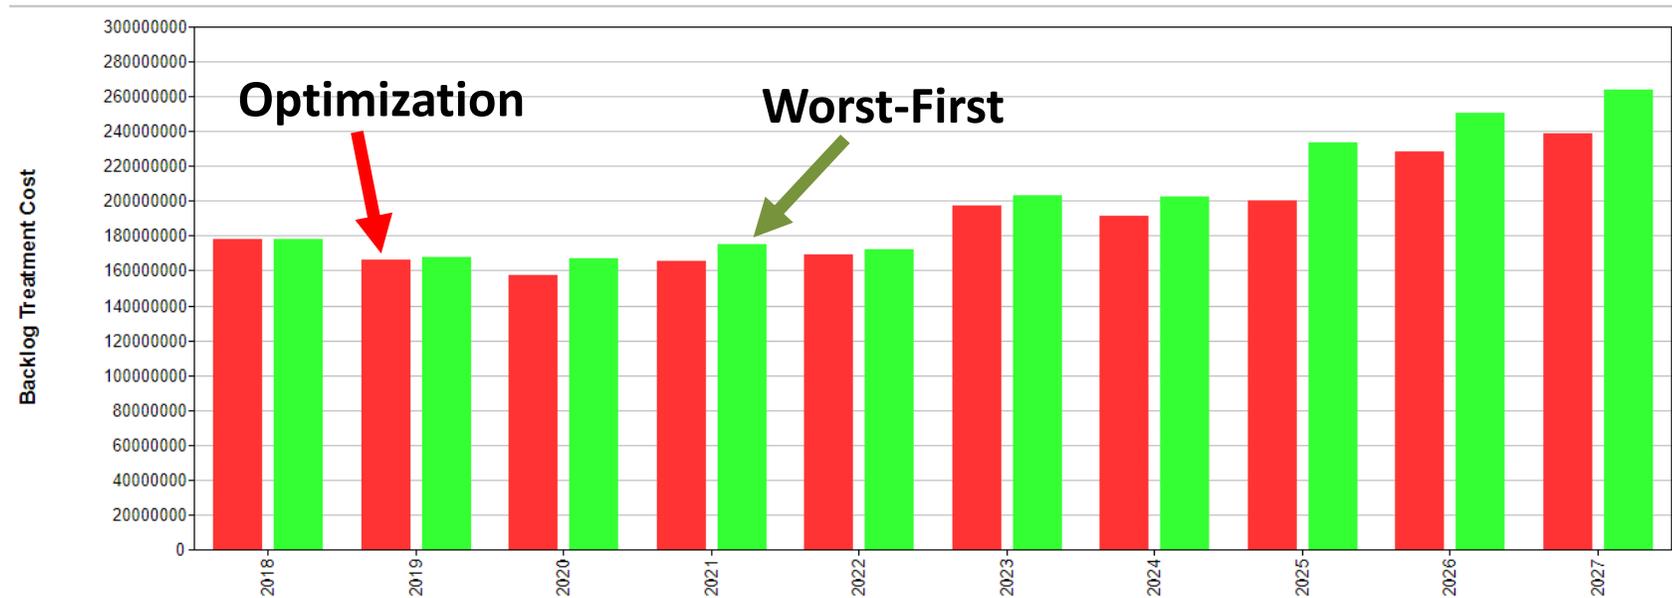
**Minimize
Backlog &
Costs to
Public**

Total Backlog Cost in 2027:
Optimized: \$238.5 Million
Worst-First: \$263.9 Million

**Money Saved by Improving
Management Process:
\$25.4 Million**

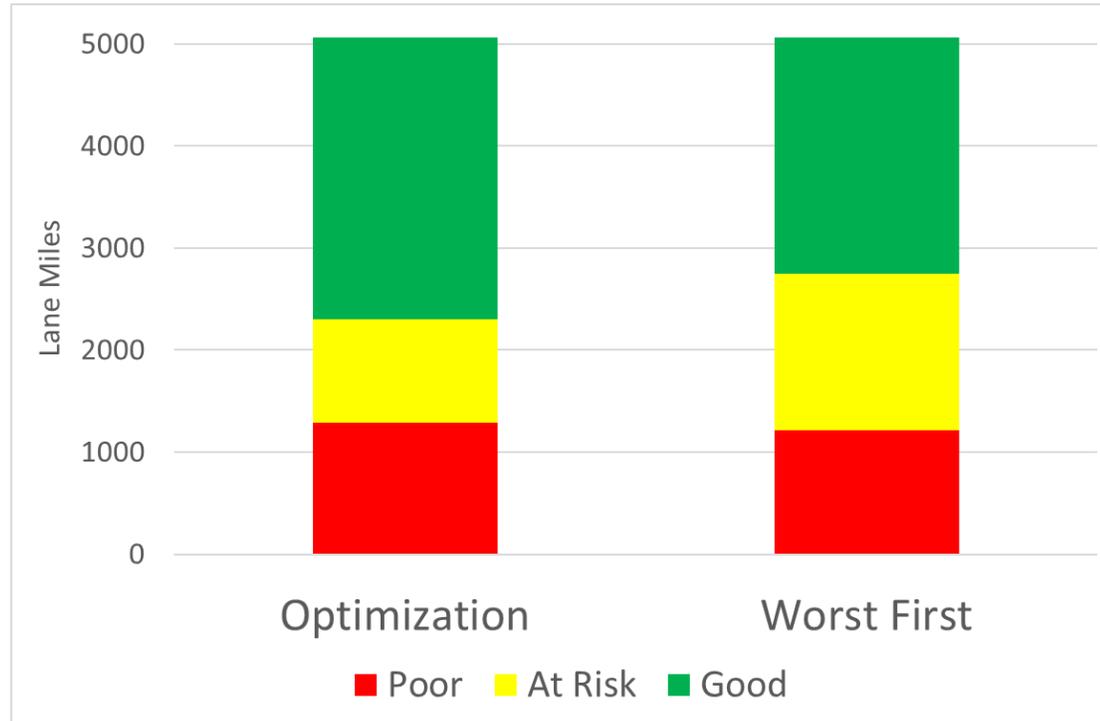
Inventory Condition

Percent Increase of Good Roads by 20% with similar percent Poor Roads

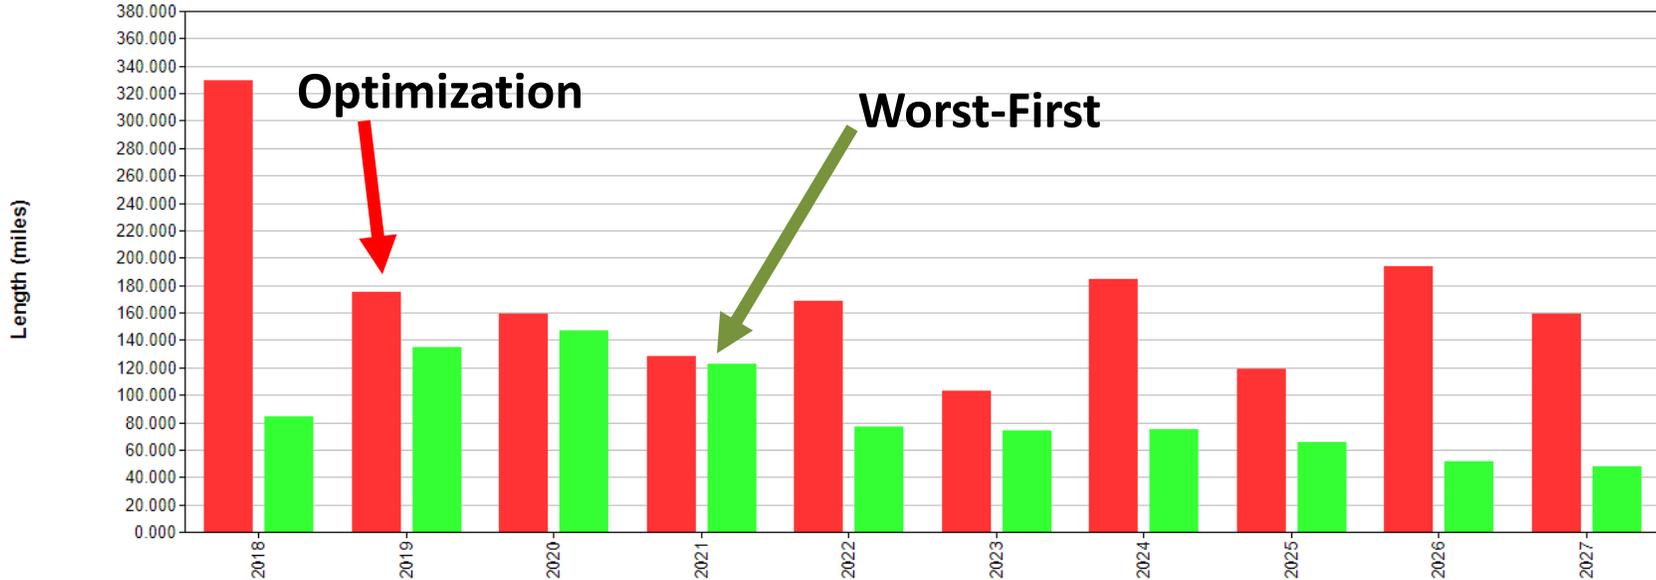
Increased
Visibility to
Public

Total Centerline Miles Treated over 10 Years (2,529 mile network)

Optimized: 1,719 miles (68%)

Worst-First: 879 miles (35%)

**% Increase in Roads
Repaired: 95%**
